MAINTENANCE ADVISORY

Crankcase Vent Tube Modifications to Prevent Potential Radiator Failures on the MEP-903 10 kW Auxiliary Power Unit (APU)

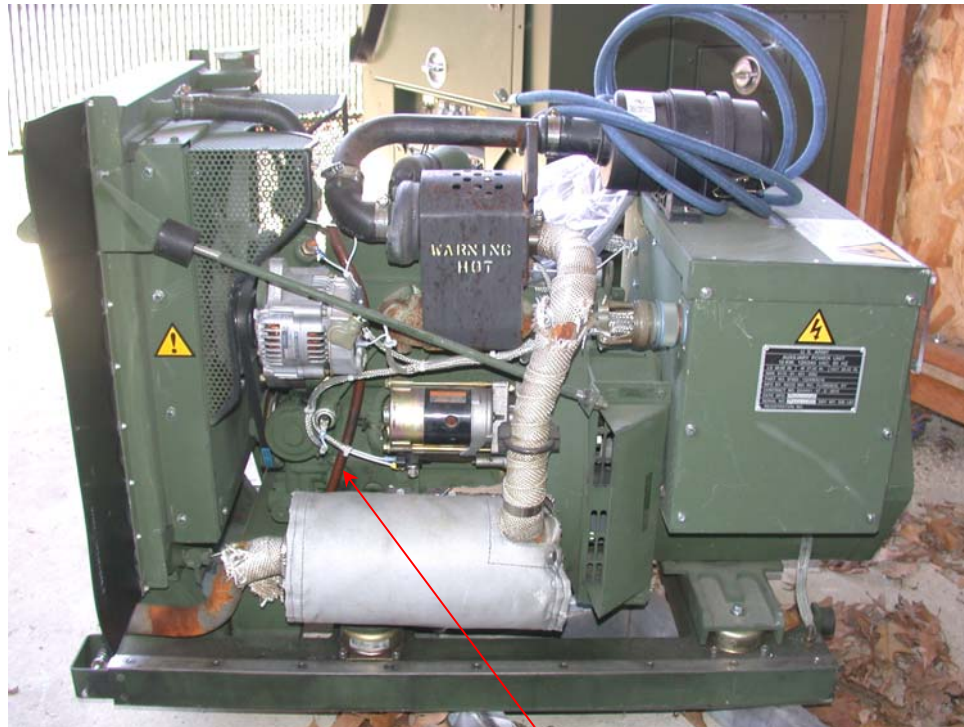
CRANKCASE VENT TUBE

Numerous radiator failures have recently been reported for the MEP-903 10 kW APU. The problem could be due to multiple causes. One potential cause has recently been identified. Field representatives have observed oil vapors from the APU's crankcase vent tube being drawn into the radiator by the radiator fan. These hot, oily vapors can cause sand and dust to adhere to and block the radiator cooling fins. This blockage results in thermal hot spots and excessive mechanical expansion in parts of the radiator, which can result in radiator leaks especially in the presence of corrosion or abnormal vibration.

1. **IMPORTANT:** Verify that the APU is off and that the muffler is not hot.
2. Locate the crankcase vent tube on the muffler side of the APU.
